THE CASE OF THE
METHODIST CHAPEL FAILURE

Human errors caused the collapse of this beautiful \$83,000 chapel. These errors were made by the architect, engineer, general contractor and sub-contractor, all of whom suffered financial loss as a result. Study of this case is especially appropriate for courses in civil engineering structural analysis and design.

© 1971 by the Board of Trustees of the Leland Stanford Junior University, Stanford, California. Prepared by Professor Paul H. Sanders, Georgia Institute of Technology. Published with the support of the National Science Foundation.

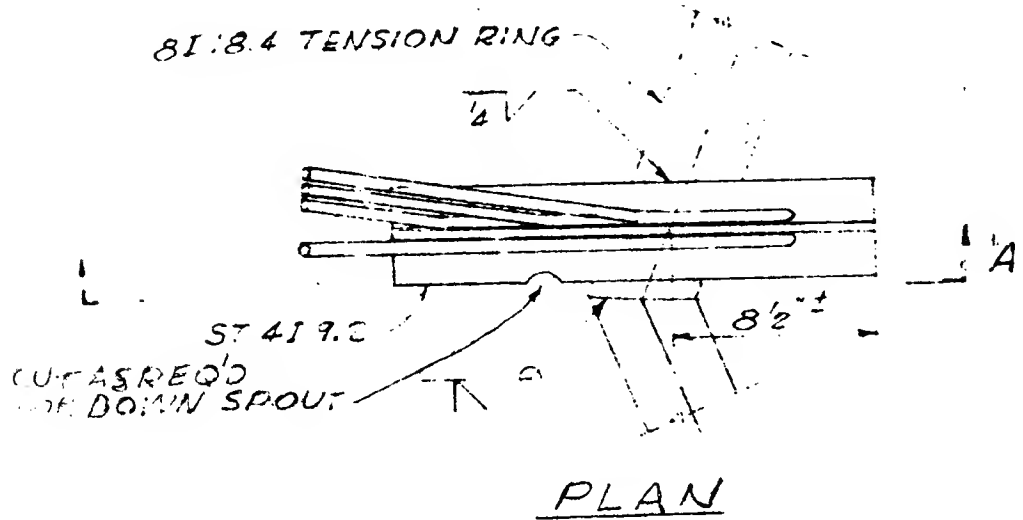
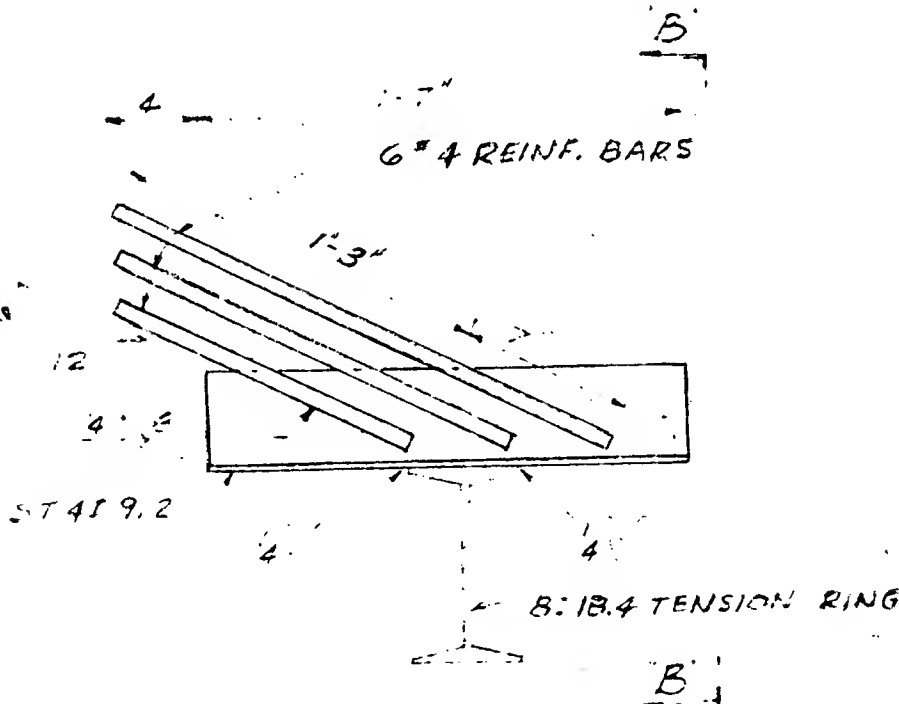
Figure 8

He pulled out from his stack of papers the eighth (Figure 8) in his series of drawings. It was an excerpt from the architect's drawing which showed the symbol for "bevel groove weld, all around".

He continued that Joe Church, the structural engineer, was quite correct when he called for the welding to be done according to the symbol shown on Figure 8, the architect's drawing.

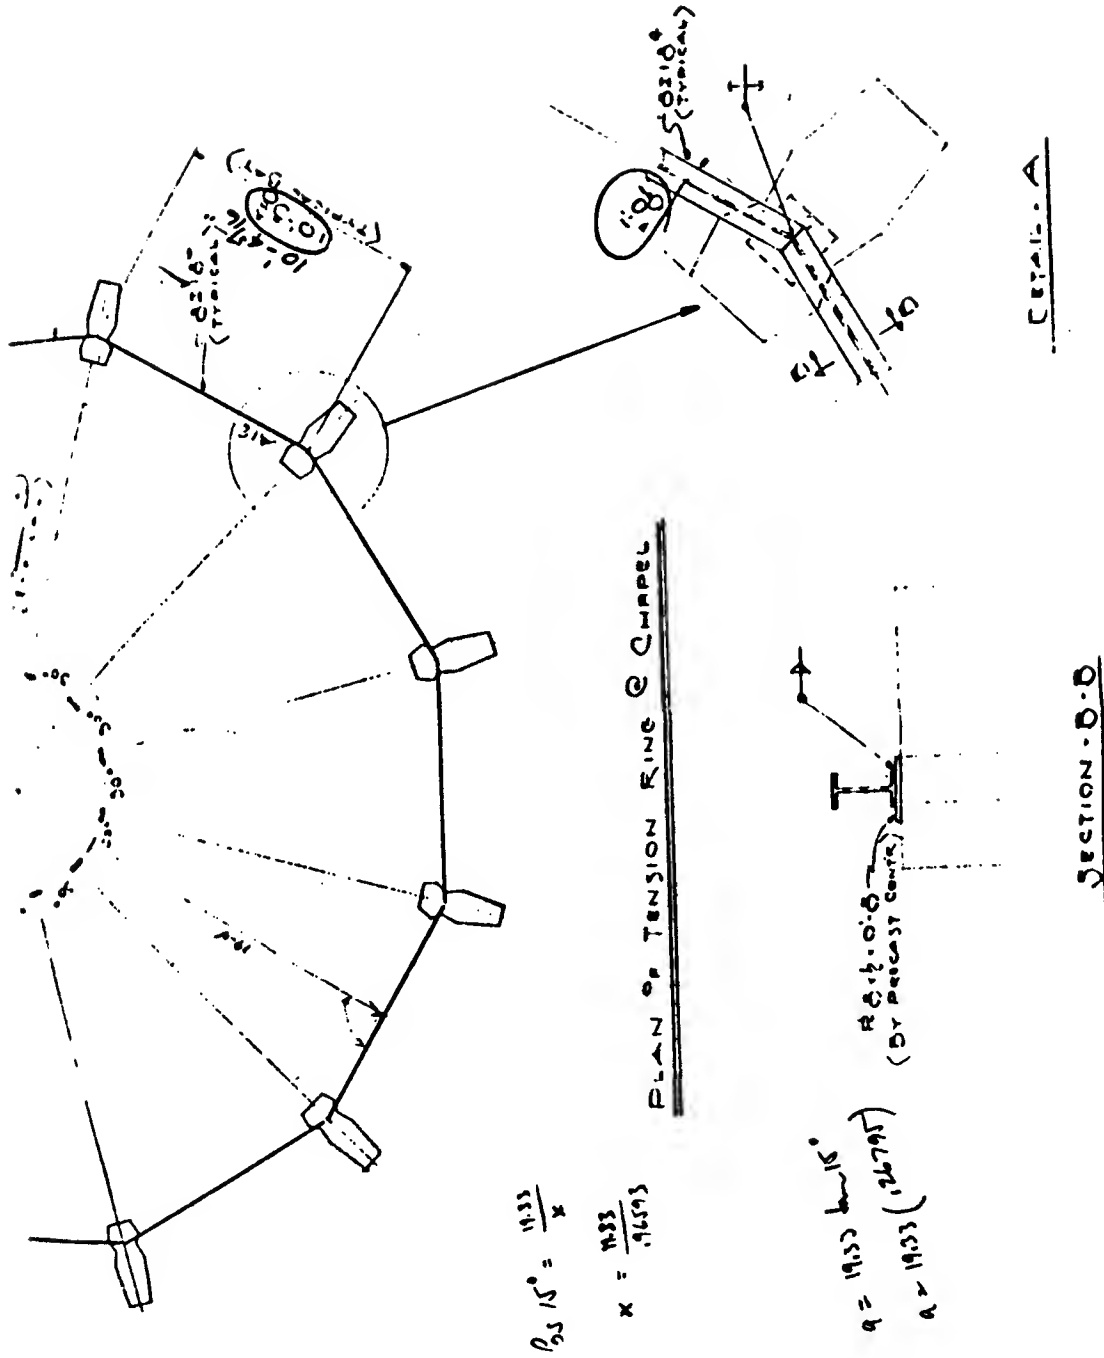
Figure 9
Marked "FOR APPROVAL ONLY" - Steel Fabricator

Figure 9 was quite a different story. This was from the steel fabricator's drawing marked "for approval only" showing the symbol for "flash or upset resistance weld, convex contour, field weld".

"You were right," Petrie said. "In 1946 those weld symbols on the steel fabricator's drawings meant 'butt weld'! So now I think I've got an explanation for the weld symbol change."

"But some old timer at the steel fabricator's shop thought he saw a way to save a hundred bucks or so and changed this symbol to one which didn't require hand grinding of the bevel for the groove weld. Yet it still specified a full penetration weld," Petrie explained.

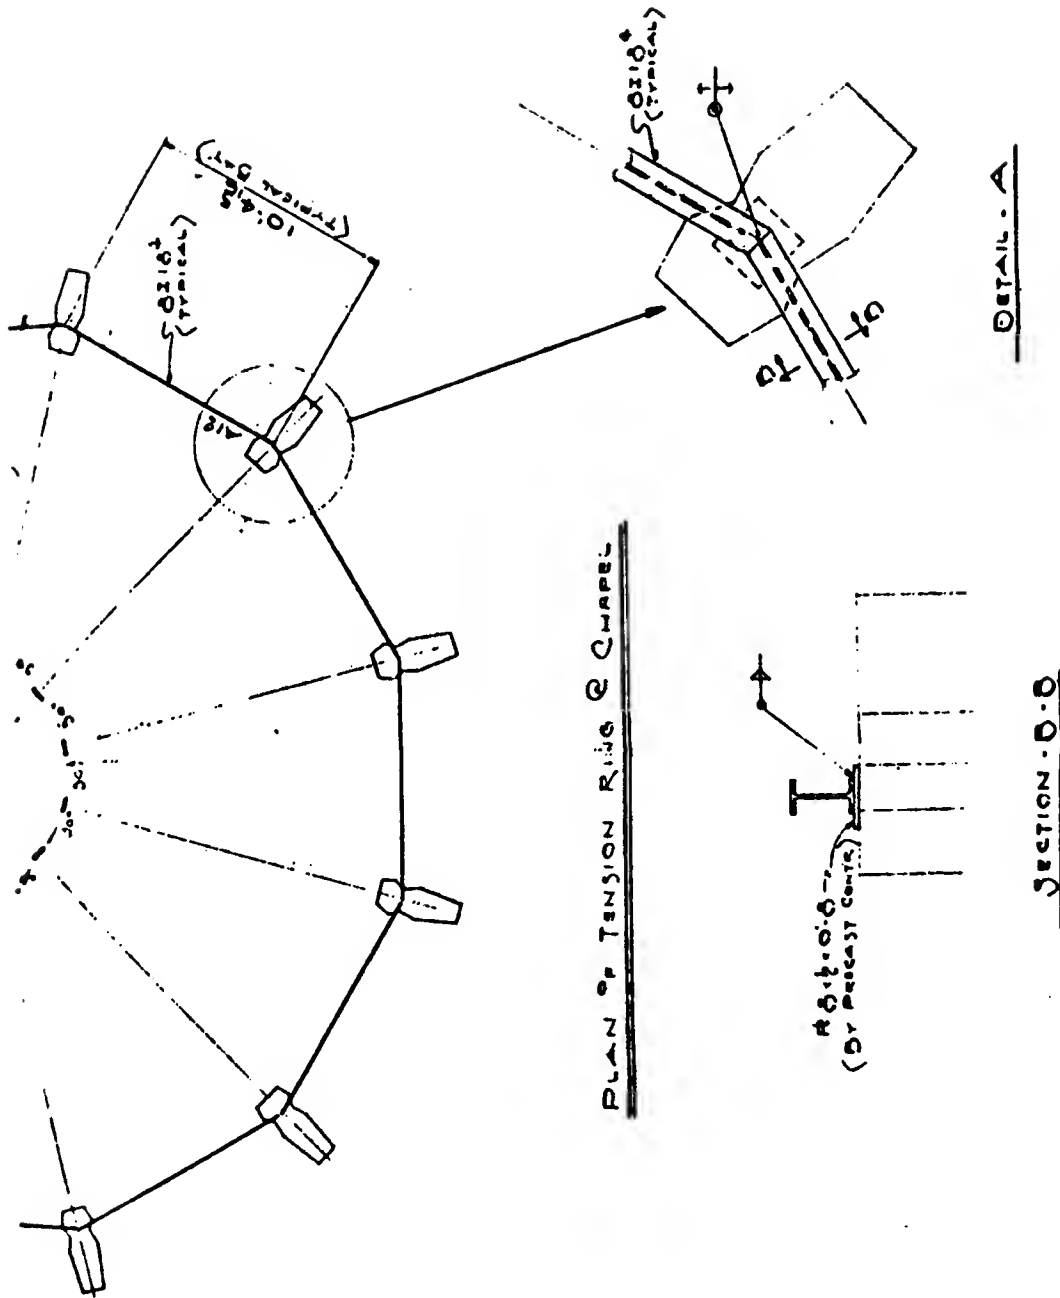
Figure 10
Marked "FIELD USE" - Steel Fabricator

Figure 10 showed an excerpt of the steel fabricator's drawing marked "field use." On that drawing, the weld symbol of Figure 9 was modified to "all around."

"The architect and engineer approved the steel fabricator's drawing not noticing the weld symbol change. And the welder employed by the erection sub-contractor, Zenith, probably paid little or no attention to the weld symbol and tried to make the best possible weld."

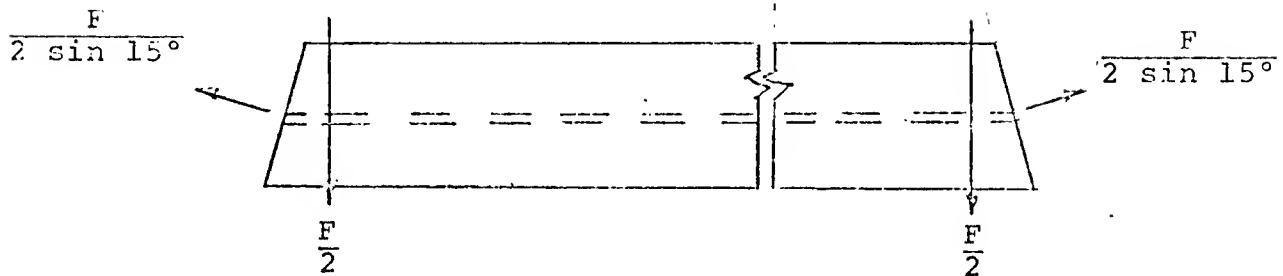
Since the web of the S8 x 18.4 is relatively thin (0.271 inches), it can be assumed that the force transmitted by it to the flange, in a horizontal direction perpendicular to the web, is negligible. Therefore, the normal force resisted by the weld in Figure 11 is calculated by (F from Figure 3)

Using the section properties of the welded face, the maximum dead load tension stress in the weld (at the top of the beam) is

The maximum live load tension stress, calculated similarly using a live load of 25 psf, is approximately 2.5 ksi. The total dead load plus live load tension stress is therefore 17.7 ksi. The maximum allowable stress for a weld which meets applicable codes and specifications is 21.6 ksi (for E60 electrodes and A-36 steel).
